Part Six: Where The XJS Rusts and Why *(Previous instalments available by request)*

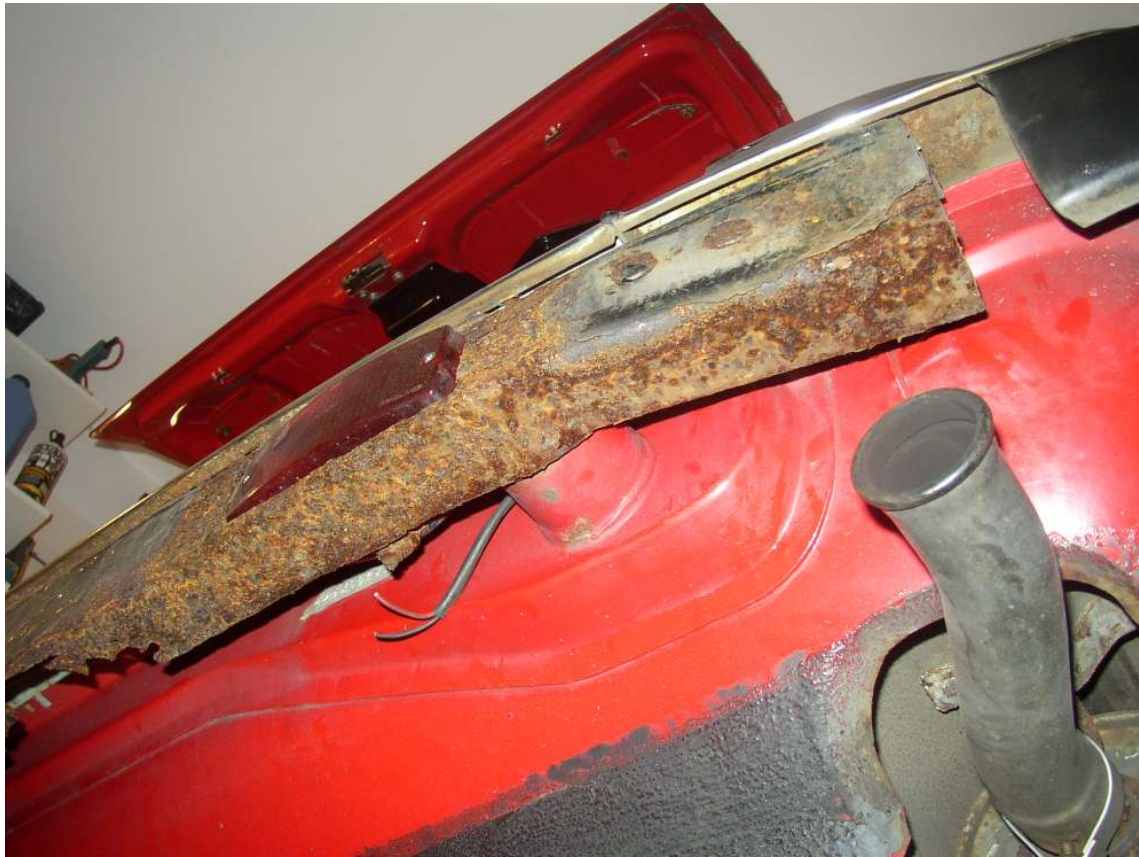
Rear Bumper

These beams rust! Water gets between the steel pressing and rubber moulding and works away until it has reduced the beam to a crumbly mess. If you put your hand behind the beam and feel around within the 'U' then you'll get a good idea of its condition. If you feel smooth paint without barnacles and no laminations of rusty steel then leave well alone, for the near future at least.

As mentioned before, the beam is secured to the irons by four captive bolts retained in the beam itself. They have the same head as a coach bolt and are retained in a square hole in the beam. The nuts on the other side of the iron will almost certainly be well rusted to the captive bolts. As with the chrome bumpers, if you don't soak these nuts in penetrating oil for a couple of days anything more than gentle application will see the captive bolt turn in the thin beam and turn the square hole into a round one. You will then spend the rest of the day huffing and puffing and falling out with anyone who comes near you whilst trying to liberate the nut from the bolt, it really is that bad!

If the initial prognosis is not good then it might be wise to remove the beam and give it a once over. Although the beam does not support any of the chrome bumpers it's a lot easier if these 3 items are removed prior to getting the beam out.

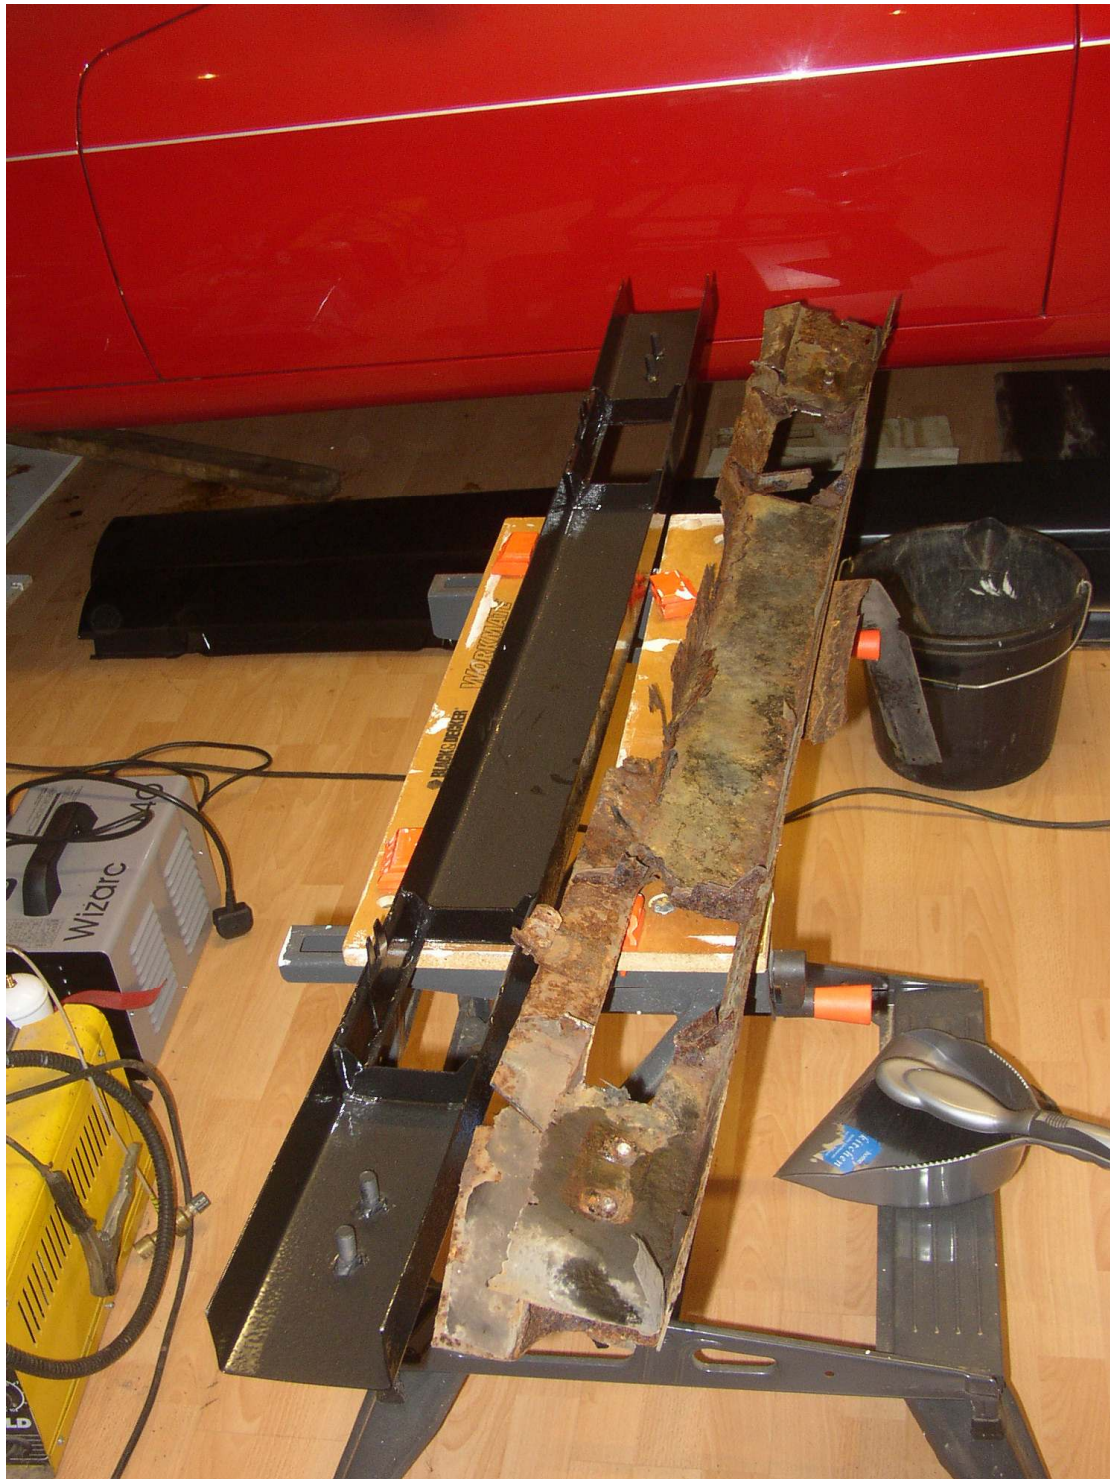
Bumper beam – new (left) and old (right)

Before you pull the beam free remember to disconnect the fog light wiring. Gently prise the spring clips holding the rubber to the beam and then pull the beam out of the rubber. Once out on its own it will become obvious whether the beam is salvageable or not.

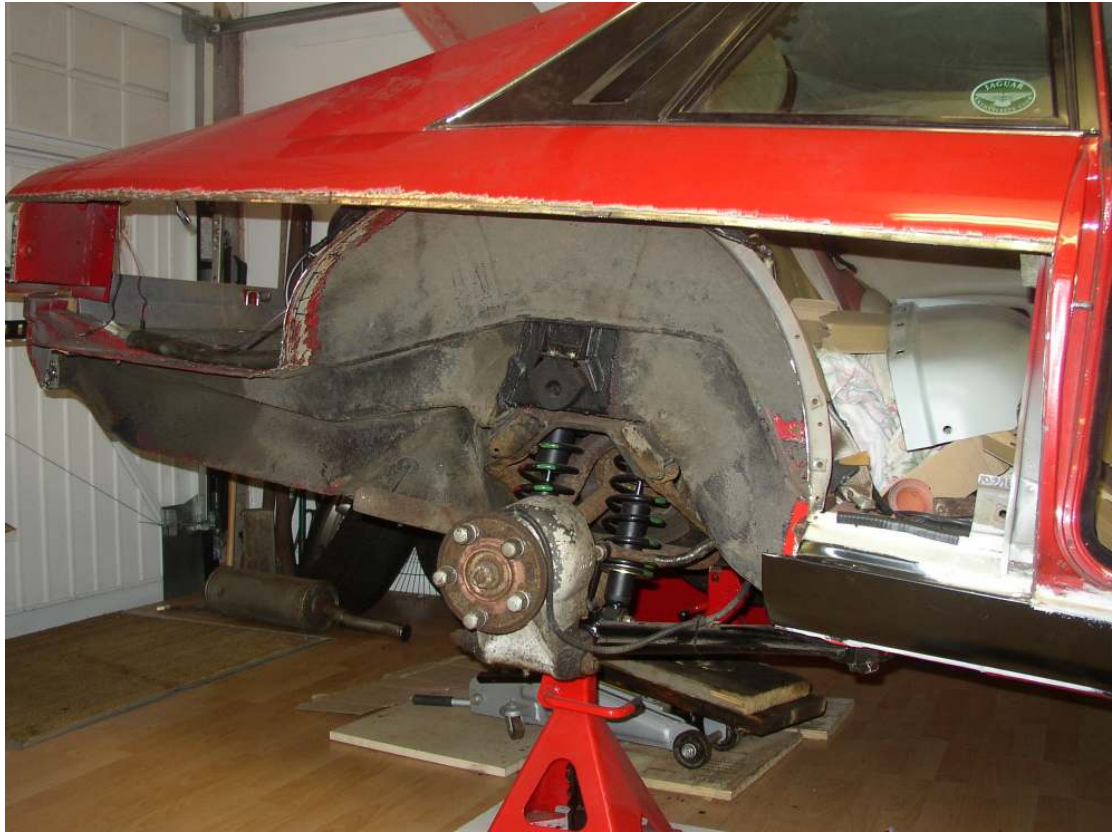
One big hole!

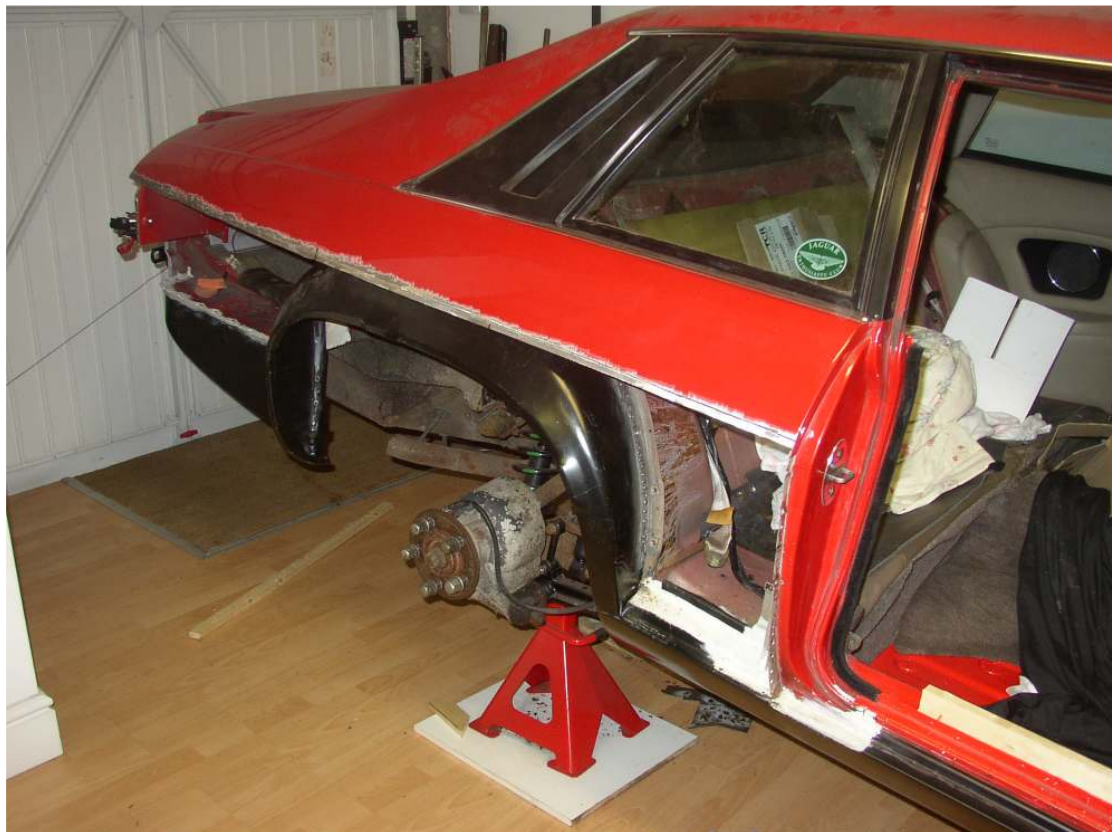
New inner arch fitted

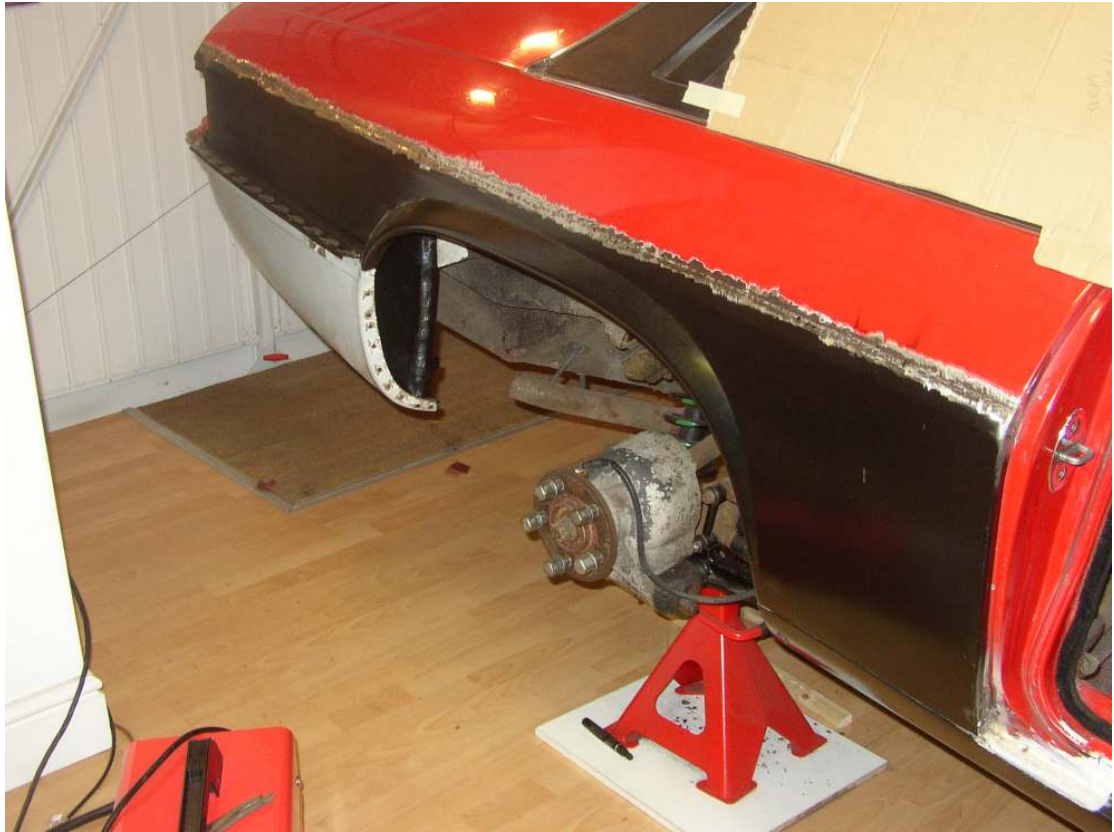
Repairs completed!

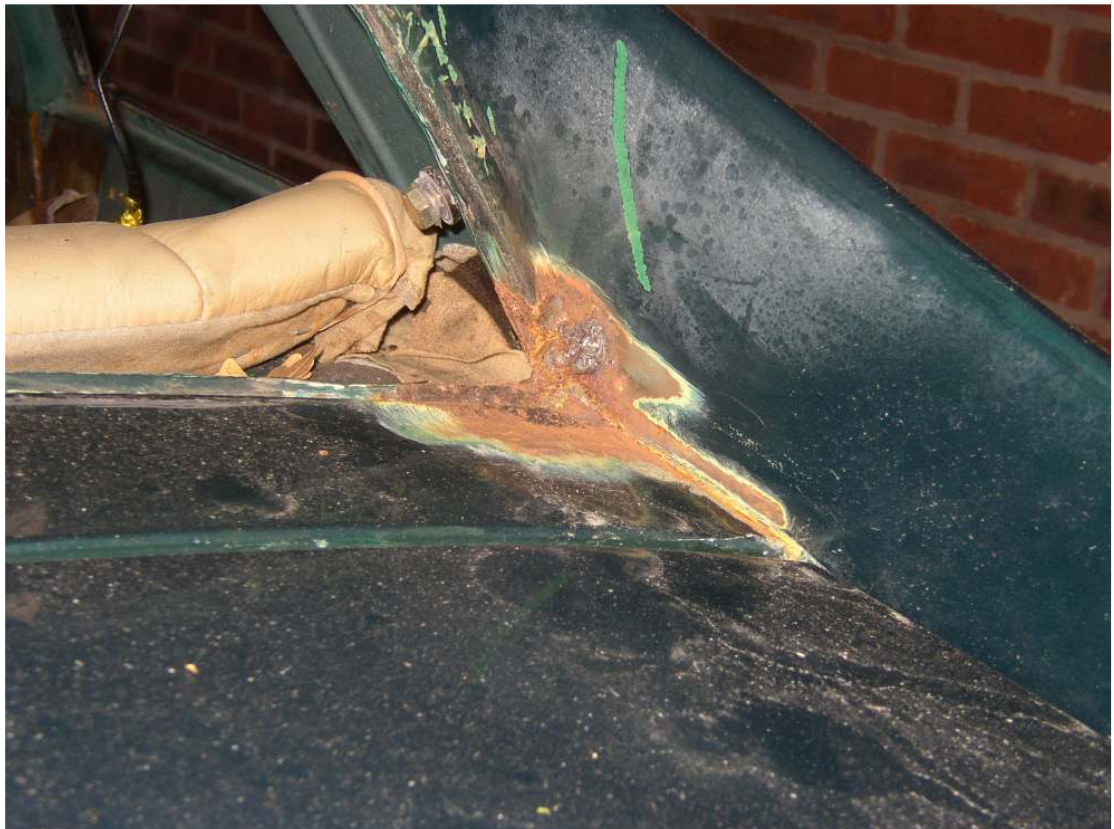
Rear (flying) Buttresses.

Some rot out, some don't, but given enough encouragement they generally will. The encouragement is in the form of a dirty unloved car exposed to the elements. This allows dirt and organic matter to build up at the base of the buttresses where they meet the boot lid and rear window apertures. There is also the previously mentioned theory of acidic fumes from the battery. Sometimes it's quite obvious that the metal has rotted from the inside out resulting in scabby holes half way up the buttress, far away from any time gathered detritus. Wherever your car chooses to rot, if its kept clean and dry, in and around the boot area (with all drain holes clear and free) then the buttresses should remain pretty well preserved.

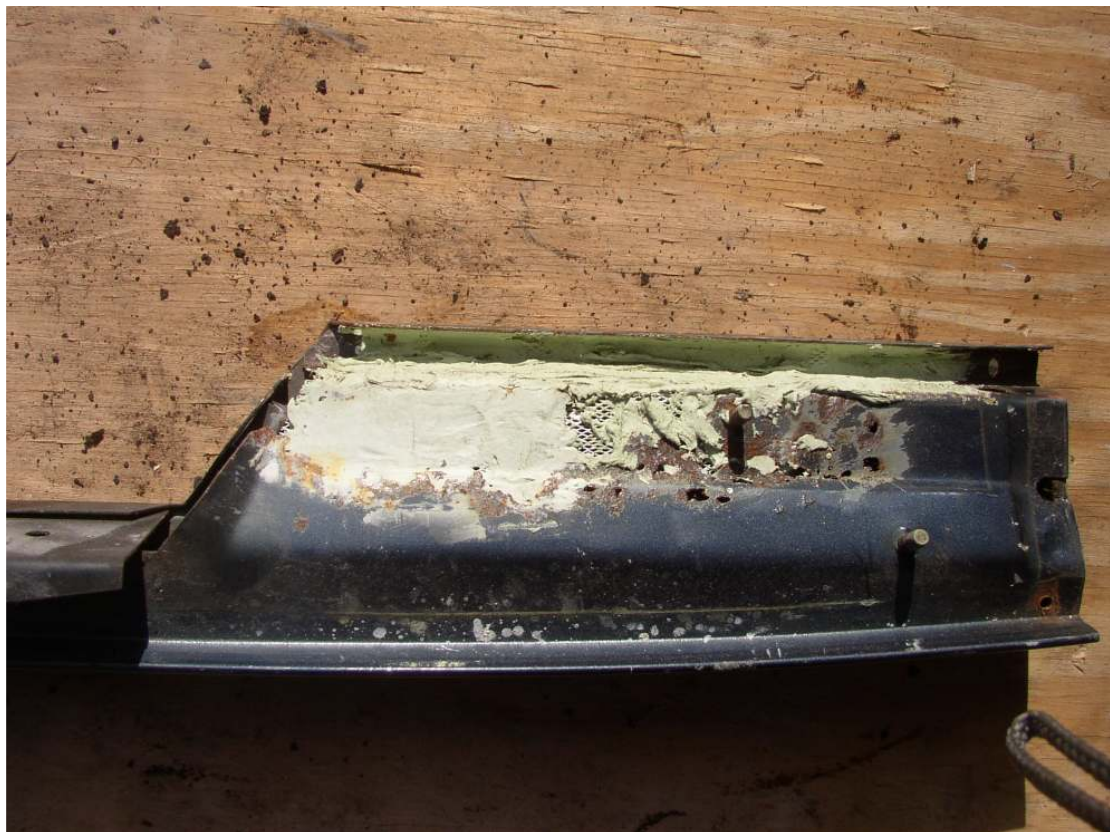
Boot plinth rust and boded repair

The boot lid and bolt on plinths are a different kettle of fish. The boot lid tends to go on its lower edges, where the outer skin folds over the inner framework. This can continue all around the underside of the lid. The test for rot follows the same pattern as before, check the internal seam all around the boot periphery, if it's not clean and well defined then it's either corroded or has been filled in one way or another.

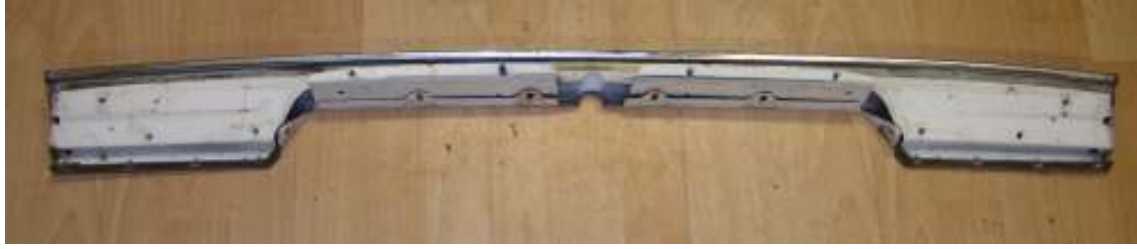
Plinth rear

The boot lid plinths are hollow sections bolted to the top rear of the boot lid. They collect muck and moisture on their internal parts and just rot away with ease. The full extent of this is not apparent until the plinth is removed, but any blistering on the outer faces generally means trouble.
